# Manhole Inspection Summary

Manhole # S21AA2062MH

**Location** Address: **1190 FALLS RD** Cross Street: **NORTHERN PKWY**

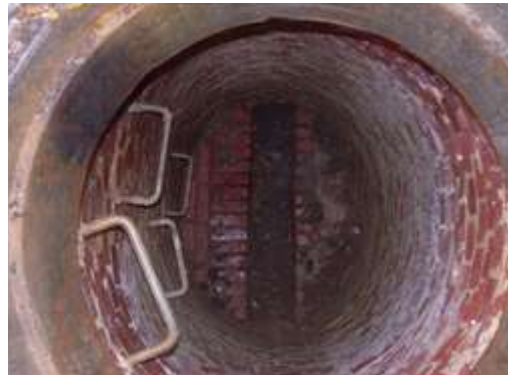
Top View

Evidence of surcharge - Bench debris.  
Channel debris.

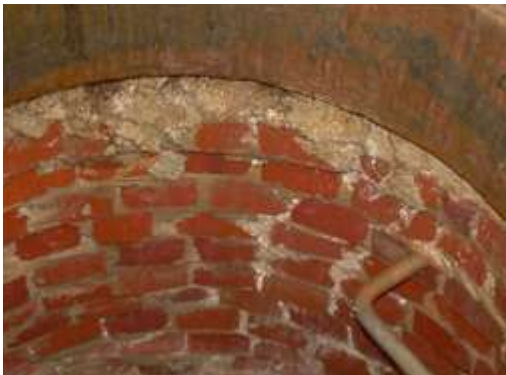
Defect

Adjustment infiltration.

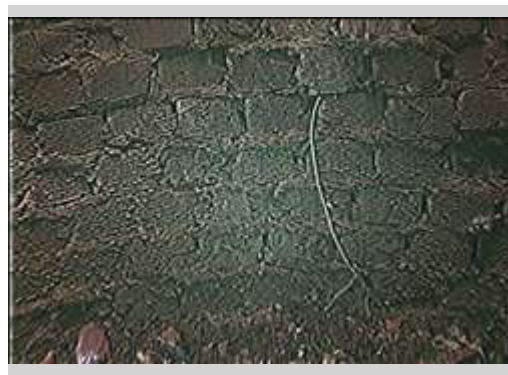
Defect

Barrel deterioration, root intrusion and  
infiltration. Bench debris.

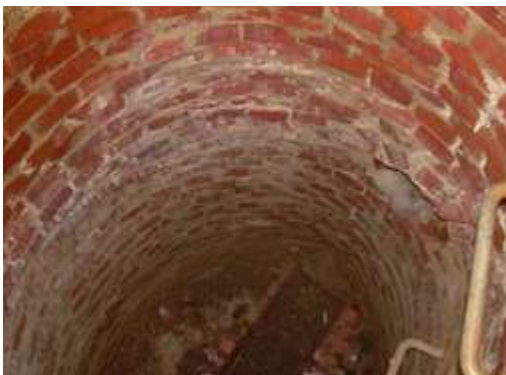
Defect

Barrel infiltration.

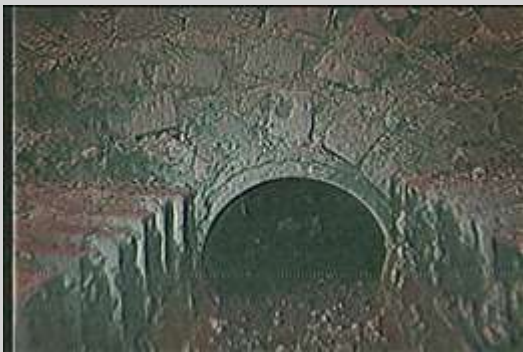
## 10 in. Circular Gravity Sewer Pipe Out @ 12 O'Clock

Deposits: ☐ None ☒ **Mud** ☐ Sludge ☒ **Debris** ☐ Grease

Silt Depth: **2** (in.) Deposits Extent: **Medium**

Infiltration: **Evidence** Pipe Seal Cond: **Unknown**

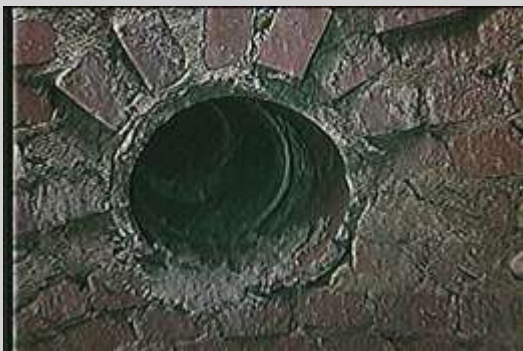
## 10 in. Circular Gravity Sewer Pipe In @ 6 O'Clock

Infiltration: **Evidence** Pipe Seal Cond: **Cracked**

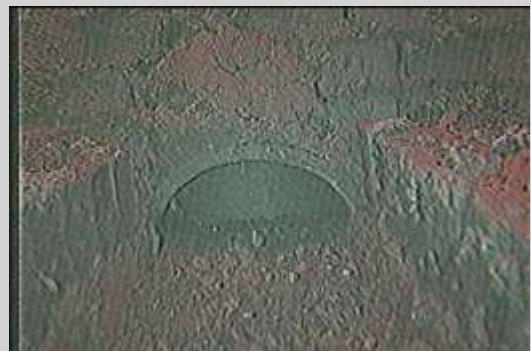
## Drop In @ 6 O'Clock

Barrel deterioration and infiltration.
